HIGH POINT PIER

ANTIGUA, W.I.

# UNDERWATER FACILITIES INSPECTIONS & ASSESSMENTS

PREPARED BY ROBERT TAGGART INCORPORATED UNDER  
CONTRACT N62477-80-C-0161, TASK 4, FROM DATA  
FURNISHED BY UNDERWATER CONSTRUCTION TEAM ONE

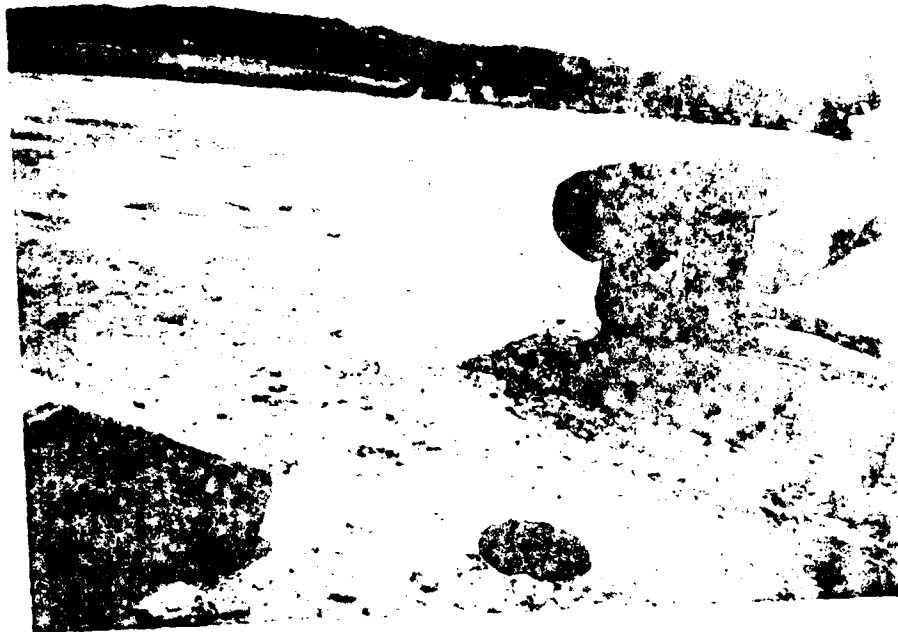
FIGURE 3-1  
FROM DECK LEVEL

The decking and mooring fittings of the offshore portion of the High Point Pier are in extremely poor condition as can be seen in the photograph, Figure 3-1. Although there were no drawings available, it appears that at one time a utility tunnel ran part way out along the south edge of the deck. The pier edge is reasonably intact along most of the offshore portion periphery, Figure 3-2, but, in way of the tunnel, the deck has collapsed as shown in Figure 3-3.

The decking of the offshore portion of the pier appears to be structurally capable of performing its intended function. However, the deterioration that has begun will continue unless repairs are undertaken which will both prevent further deterioration and improve considerably the utility and appearance of the pier. It is suggested that the collapsed portions of the deck be removed and that the utility tunnels, which apparently are not required, be filled with aggregate. Furthermore, it is suggested that the entire offshore portion of the pier be covered with a 4-inch layer of reinforced concrete extending 6 inches outboard of the existing 52 by 235 foot deck on the north, east, and south sides of the pier. Poured at the same time should be a 6-inch wide by 4-foot deep facing of reinforced concrete which would extend down to the bottom level of the existing stringers. The reinforcing for this facing should be securely attached to the existing face and the forms should extend beneath the existing deck so as to pour replacements for missing stringers along the north and south faces.

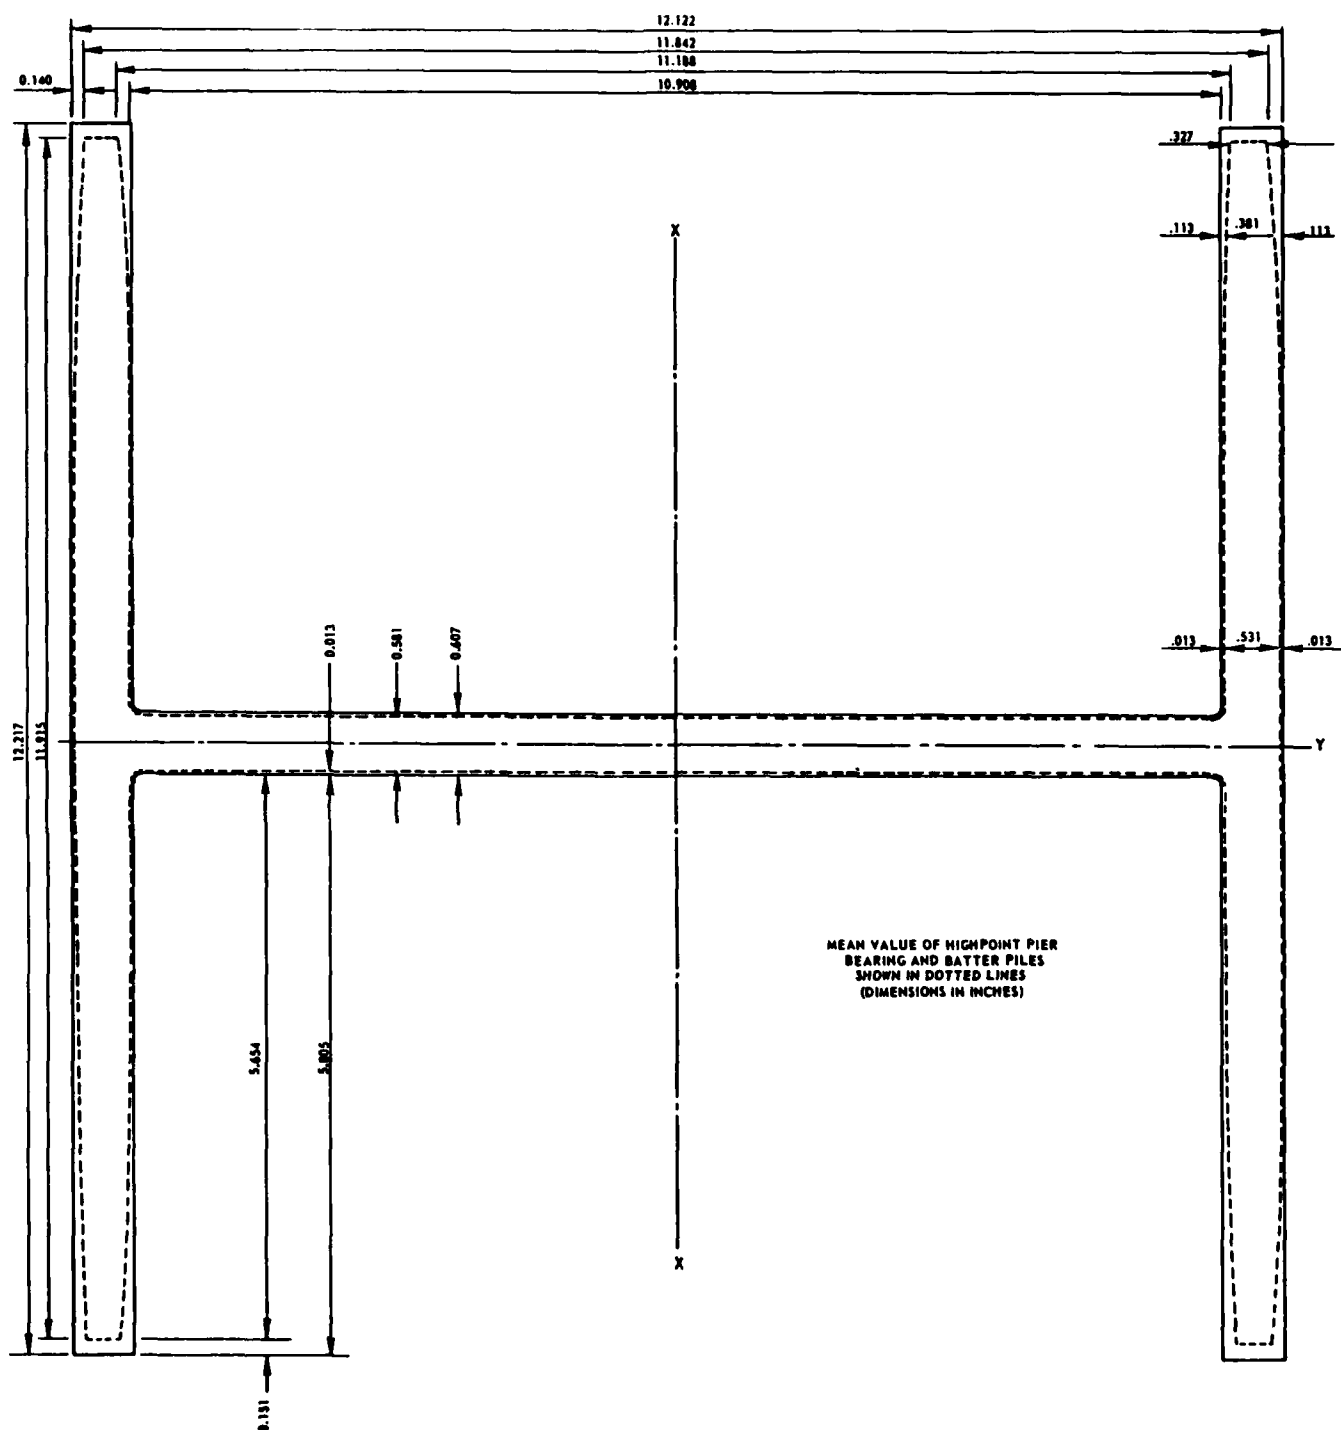
FIGURE 4.1

DERIVED H-PILE CROSS-SECTION  
COMPARED WITH AISC DIMENSIONS

It is believed that the third method of mean pile characteristics derivation most accurately represents the average condition of the High Point Pier. On this basis it can be stated that the support structure can carry a load approximately 80% of the original capacity of the pier.
